SUBJECT: Action Memorandum for an Emergency Response Action at the Klamath Falls Motel Mercury Site, Klamath Falls, Klamath County, Oregon, Pursuant to the On-Scene Coordinator's Delegated Authority under Section 104 of the Comprehensive Environmental Response, Compensation, and Liability Act (CERCLA)

TO: Administrative Record
Klamath Falls Motel Mercury Spill Response

Site ID: 10TF

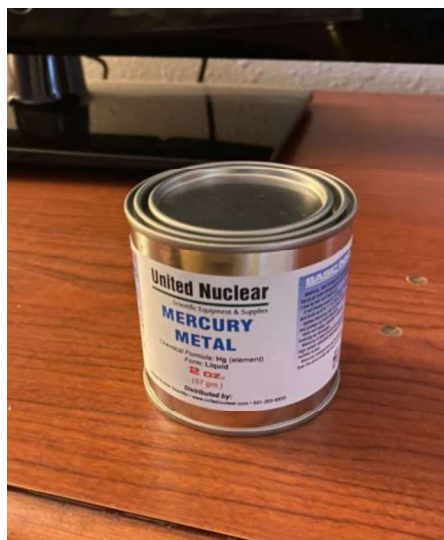
The attached photo of the mercury container shows an outer metal paint can labeled as containing two ounces of elemental mercury, and it is believed to have contained an inner vial of elemental mercury. A conservative estimate of up to two fluid ounces of elemental mercury could have been released into the environment with an unknown amount remaining as residue in the vial when the individual spilled the vial of mercury onto the motel room carpet and some bedding in the small 16-foot by 16-foot room.³

During the response, EPA observed multiple beads of mercury on the carpet and measured high levels of mercury vapor (up to 10,000 ng/m³ in ambient air) as well as in the air space just above surfaces in the motel room.
